## **Efficacy of Radiological Decontamination**

TECHNICAL MEMORANDUM  
DREO TM 2001-060  
August 2001

D.S. Haslip, T. Cousins and B.E. Hoffarth  
*Radiation Effects Group*  
*Space Systems and Technology Section*

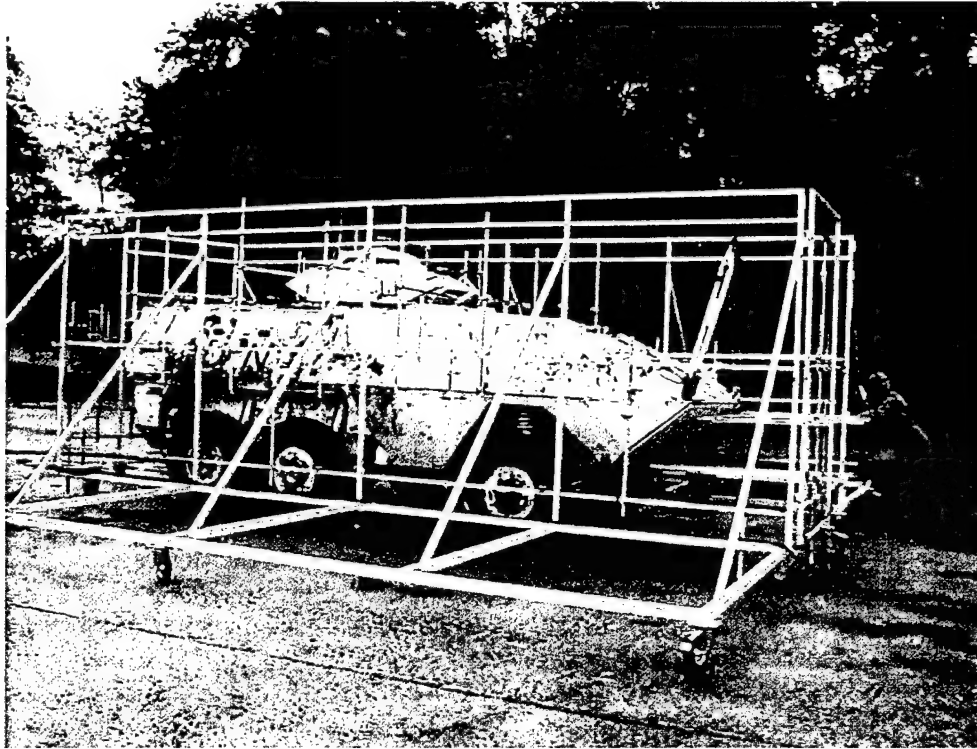
**Figure 1.** *Measuring contamination levels with the ETBS cage. Seventy-seven Geiger tubes are suspended by the metal structure. The cage rides on wheels, allowing it to be rolled into place, enclosing the vehicle.*

Once the radioactive sand has settled out of the air, the vehicle is moved out of the contamination area to an outdoor concrete pad where its exterior contamination distribution is assessed. This is done by ETBS with 77 Geiger tubes mounted on a specially designed steel "cage" (see Figure 1). The cage envelops the vehicle and allows each Geiger tube to be positioned reproducibly at the same location on the vehicle each time the measurement is made. Each Geiger tube is placed about 5 cm from the surface of the vehicle. Since Geiger tubes measure dose rates, and since the contamination pattern on the outside of the vehicle is not uniform, it is difficult to infer contamination levels from this measurement. However, a rudimentary assessment can be made, and the measurements are very useful for identifying the differences in contamination levels over the surface of the vehicle. The Geiger tube measurements are performed prior to decontamination and after each stage of decontamination to monitor progress.

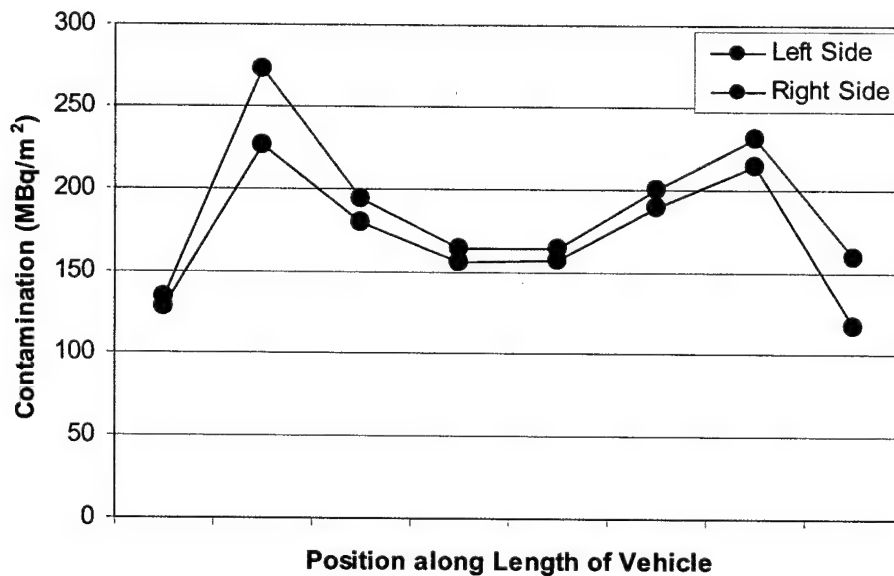
**Figure 2.** Contamination levels measured on the witness plates next to the Grizzly in the contamination area.

As noted above, the first measurement of the vehicle contamination is performed in the fallout room. One row of witness plates is placed on each side of the vehicle prior to contamination and is collected following contamination and measured. Figure 2 shows these measured contamination levels as a function of distance along the length of the vehicle. The series labeled "left side" denotes the side on which the driver sits. Points corresponding to the front of the vehicle lie on the left side of the graph. The contamination level on the witness plates is  $180 \pm 40$  MBq/m<sup>2</sup>. The figure shows that the right side appears to be slightly more contaminated than the left, and that the front-to-back variation is the dominant one, in the neighbourhood of 23% (evident from the uncertainty quoted above).

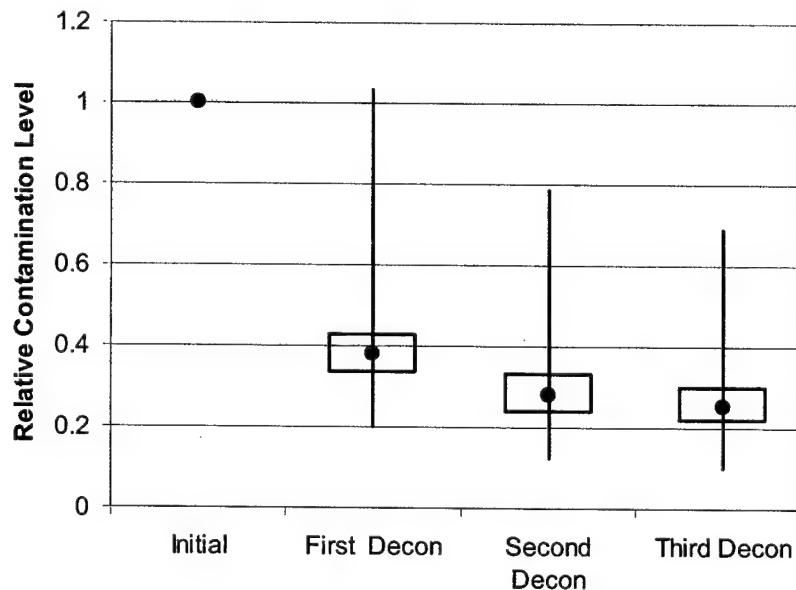
**Figure 4.** Box and whisker plot showing the relative contamination levels (according to measurements from the Geiger tube cage) on the vehicle after contamination and after each of the three phases of decontamination. In a box and whisker plot, the vertical line defines the maximum and minimum of the distribution, the box defines the upper and lower quartiles, and the circle denotes the median.

A large quantity of data was collected in these trials, especially with respect to external contamination measurements. Before decontamination and after each of three decontamination attempts, the external contamination levels were measured in the Geiger tube cage. While all of these data give a good picture of the state of the vehicle as a function of time, the interpretation of decontamination effectiveness at individual locations on the surface of the vehicle is neither feasible nor useful. Variations in the surface and in the adhesion of the contamination to the surface, not to mention the complexities in what happens to the contamination as it is washed away from a given location, contribute to a very complicated picture of decontamination efficacy when viewed location by location. Figure 4 shows this clearly in a box and whisker plot of the Geiger tube measurements. While the upper and lower quartiles of these data are not widely spread, it is clear that some data points lie far away from others. For example, after the first decontamination, one of the locations was actually more contaminated than it had been the first time (a result of  $^{140}\text{La}$  transfer from a more contaminated area to a less contaminated one).

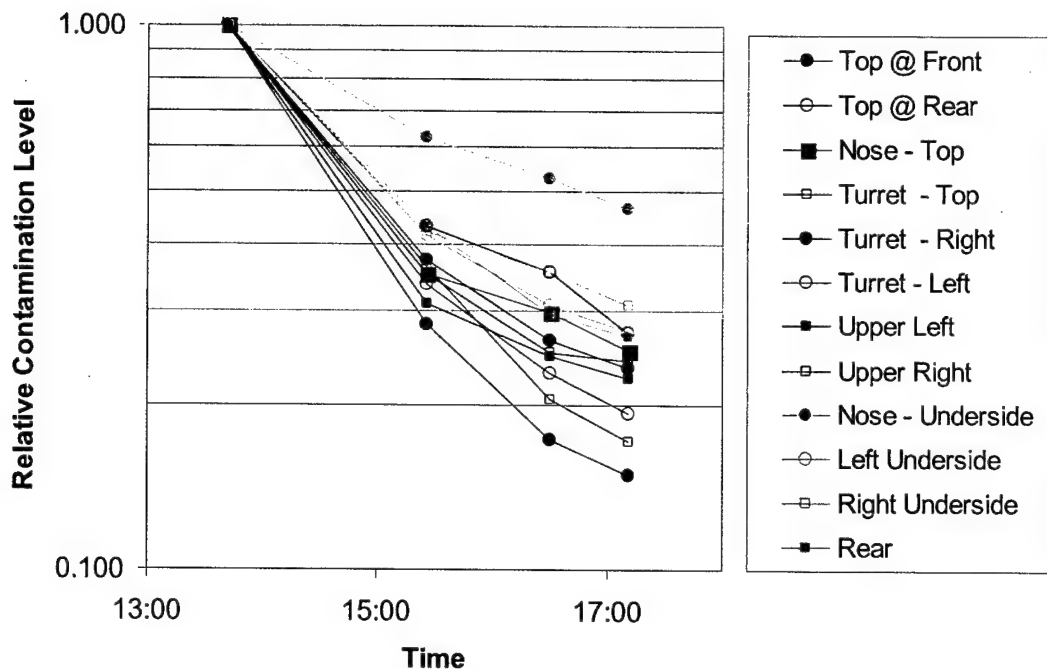
**Figure 5.** Relative contamination levels (according to Geiger tube readings) as a function of time. The 77 Geiger tube readings are grouped into 12 regions, shown in the legend. The four measurement times denote the measurement following contamination and each of the measurements following the three decontamination attempts.

The relative contamination levels (normalized to unity initially) are shown in Figure 5. This is much easier to look at than plots of 77 individual data sets and allows one to see patterns in the decontamination efficacies.

The first decontamination reduced the contamination level by 60% on average, with 73% removed by the final measurement. The semi-log plot in Figure 5 (in which regions with contamination levels falling by identical factors are represented by parallel lines) shows that the greatest difference in decontamination efficacy occurred during the first decontamination, with later attempts producing more or less similar results in all areas. The greatest outlier is the underside of the "hood" or "nose" of the vehicle. This region had very low decontamination efficacy, but this was also the area with the lowest initial contamination levels. The former result may be a consequence of the latter, in that none of the contamination initially present on this surface was loose, but all was adhered to the surface in some way making decontamination more difficult. On the other extreme, the top surfaces (in red in the plot) show the largest decontamination efficacies, an indication that some of the contamination that was initially present was loose, and thus quite easy to remove.

The behaviour of the 12 data series in Figure 5 suggest an additional grouping of the measurement points with the goal of further simplifying the data analysis. In this new scheme, the measurement points are put in the following three groups:

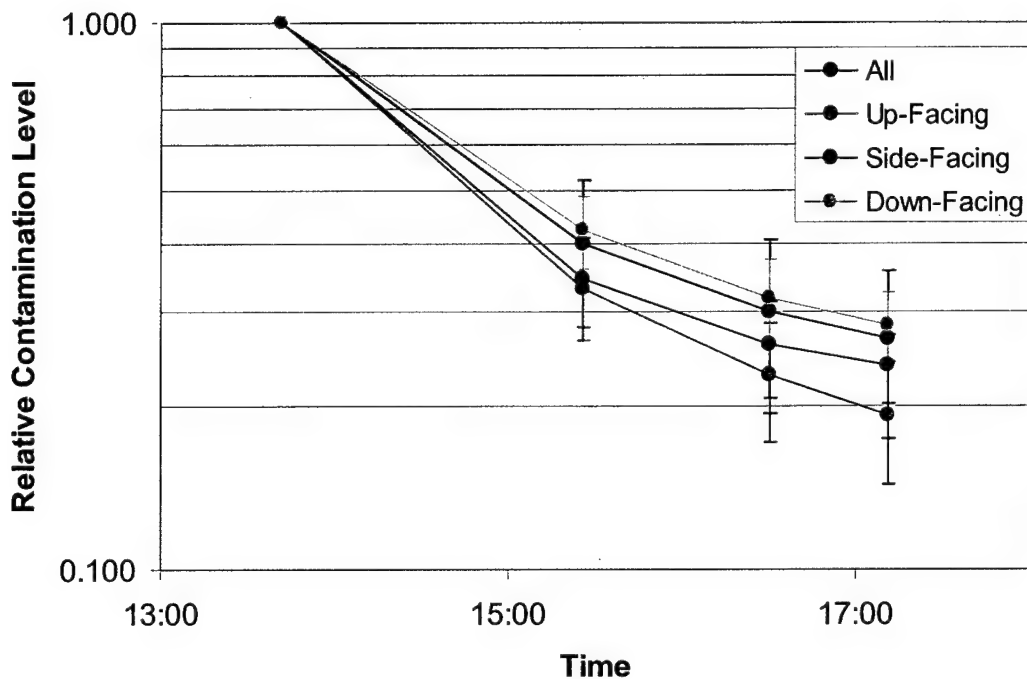
**Figure 6.** Relative contamination levels (according to Geiger tube readings) as a function of time. The 77 Geiger tube readings are grouped into 3 regions, shown in the legend. The overall averages are also shown. The error bars are standard deviations for the distributions.

Figure 6 shows the relative decontamination efficacies for these three groups, plus the overall averages. The error bars shown are the standard deviations of the groups. The trends of the data are identical to those discussed above. Namely, the "up-facing" surfaces show the largest decontamination, whereas the "down-facing" surfaces show the converse trend. Further, the differences between the data sets are largest following the first decontamination, and are more similar in the second and third attempts.

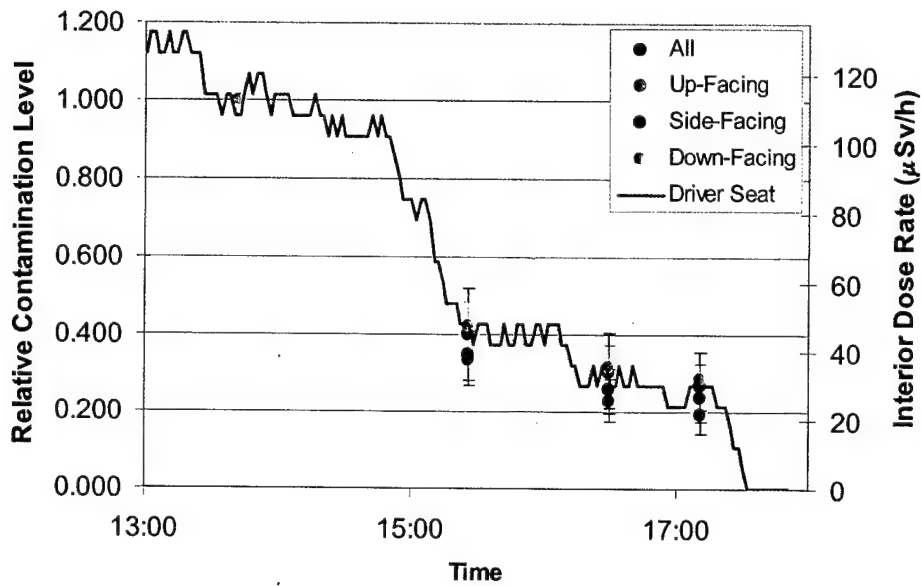
**Figure 7.** External and internal measurements of contamination. The data points are the contamination levels measured by the Geiger tube cage for each of the three surfaces defined in the previous section. The line is the dose rate measured by the dosimeter sitting on the driver's seat. The dosimeter dose rate falls to zero at 17:30 when the dosimeter when the dosimeter is removed from the vehicle.

Figure 7, Figure 8, Figure 9, and Figure 10 show the dose rate measured by these dosimeters as a function of time. For comparison, the relative contamination levels measured by the Geiger tube cage (and shown in Figure 6) are also shown in these graphs. The scale of the secondary y-axis has been adjusted so that the interior dose rates and the relative contamination levels coincide at the first cage measurement.

The interior dose rate plots are characterised by a certain amount of jaggedness. This is caused by round-off error in the dosimeters (whose dose resolution is only 1  $\mu\text{Sv}$ ). It is possible to remove this by smoothing, but the data have already been averaged over 10-minute periods, and further smoothing starts to impact an analysis of the time evolution of the contamination. All of the dosimeter plots also show a decrease to zero at around 17:30; this is due to the dosimeters being removed from the vehicle at the end of the experiment, not to a complete decontamination.

All four interior dose-rate histories are in excellent agreement with the exterior contamination measurements. This supports the trivial result that the dose rate inside the vehicle is proportional to the contamination outside. Actually, the result in this case is more important for the following reason. Despite attempts to make the Grizzly waterproof, a considerable quantity of liquid entered the vehicle during the decontamination process. This liquid was found to contain Lanthanum-140 and it was thought that this interior contamination of the vehicle might have spoiled attempts to measure protection factors. However, it appears based on these results that the contribution to interior dose rates from this liquid is small, probably because the concentration of Lanthanum-140 in this liquid is also small.

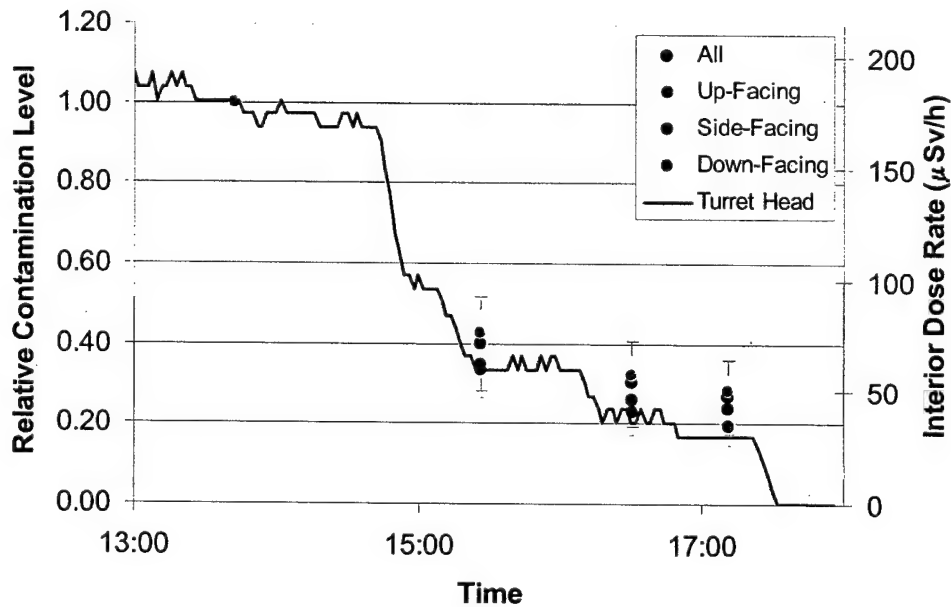
**Figure 8.** As in the previous figure, but now the line is for a dosimeter at the head position in the turret.

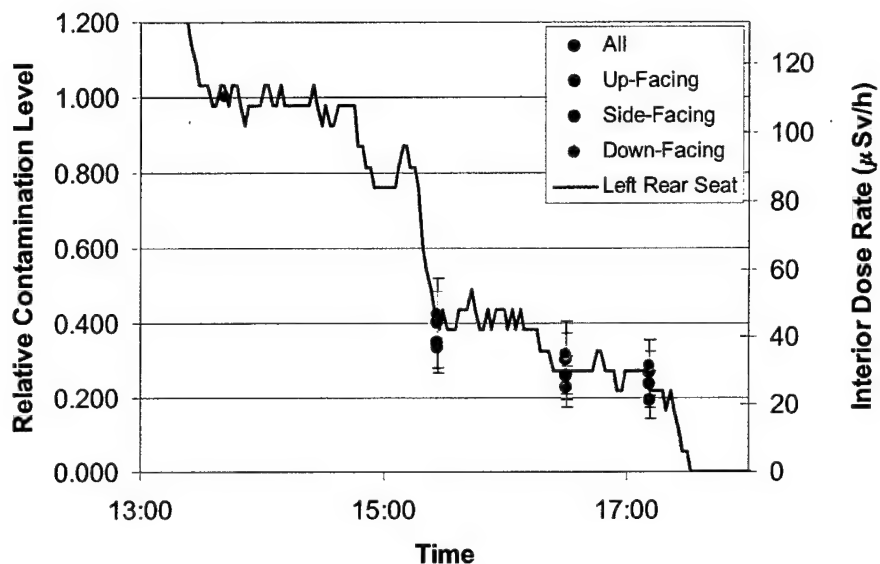
**Figure 9.** As in the previous figure, but now the line denotes the dose rate on the left passenger bench, near the rear of the vehicle.

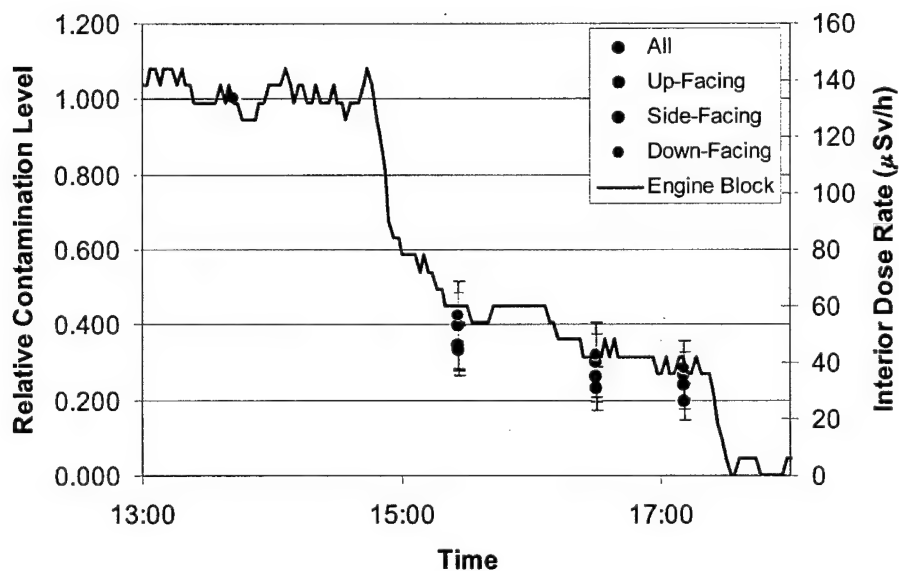
**Figure 10.** As in the previous figure, but now the line denotes the dose rate measured at waist height, immediately behind the engine compartment.

The interior measurements are actually good enough to show more than a simple consistency with exterior measurements. Indeed, the interior profiles seem to be precise enough to identify one or other of the exterior "surface classes" as being a chief contributor to the dose rate at a given interior location. For instance, both the driver's seat measurement and the rear bench measurement follow closely the trend for the "down-facing" surfaces. This stands to reason, since both locations are closest to surfaces in that category, and thus it makes sense that the trends in the latter would influence trends in the former. Conversely, the dose rates for the head position in the turret follow the "up-facing" data. This also makes sense, since this measurement point is very close to "up-facing" surfaces and far from any "down-facing" ones. The one example that does not make as much sense is the engine compartment data. These data seem to follow "down-facing" trend closely, although one might expect a larger contribution from "side-facing" surfaces to this measurement point. Perhaps interior shielding has affected this result. It should be noted that, while engine block shielding normally has an enormous impact, in this vehicle most of the mass of the engine had been removed.
